Refractory Protection over Electrolytic Cells

Location: Brazil, South America

Owner: Juiz de Fora, Votorantim Metais

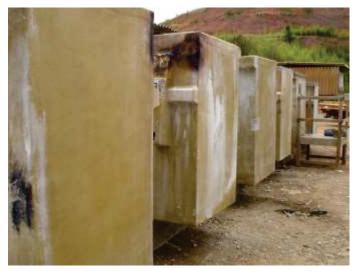
Electrolytic Cells with damage

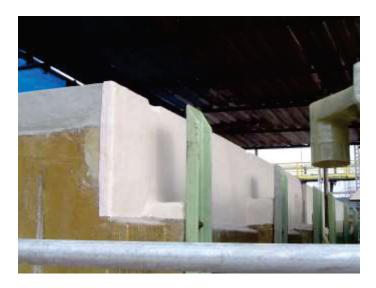
Electrolytic Cells in service after repair

Trowel applied potassium silicate mortar with fiberglass reinforcement.

- A drastic increase in the operating temperatures of the acids was corroding the previous materials rapidly.
- The installation of our 65 Mortar reinforced with Fiberglass mat, allow the material to protect the cells from the temperature as well as from the chemical attack from the hot acid.
- This restoration procedure has been applied over many of the cell with excellent results over the past several years.
- Customer is satisfied with the performance and 65 has become the material of choice for such repairs.
